THERMOGRAPHIC REPORT

Company | ABC Company
Problem # | Hot Spot 5

Location Name | West Mezzanine
Equipment | VAC Load System Control Panel

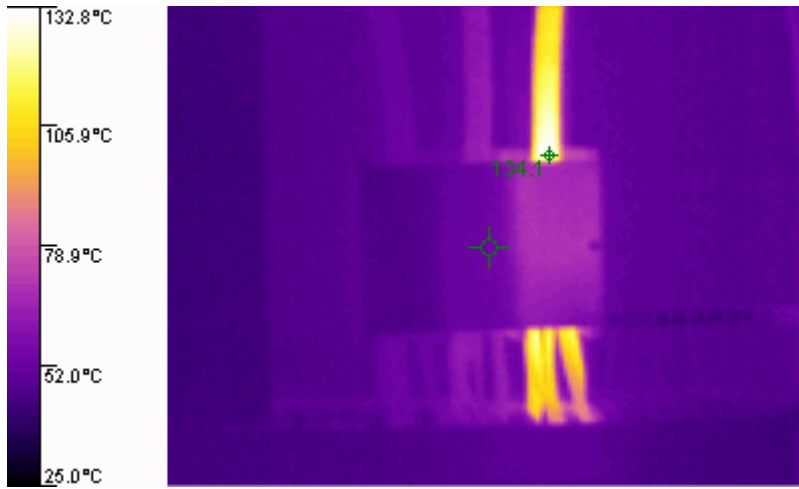
There is an extreme temperature rise on the "C" phase at the distribution block.

Image Date	6/28/2005 2:27:22 PM
Target Temperature	134.1 °C
Emissivity	1.00
Reflected Temp	OFF

Subj. Rating	Temp. Rating
Critical	Critical

There is discoloration and the conductor insulation failure is melting due to the extreme heat. Immediate attention is required to prevent and unscheduled power outage of the equipment operated from this panel. If failure occurs of this connection equipment may be damaged due to single phasing. Paul was notified at the time of detection of this condition.
